CALIFORNIA DIVISION OF MINES AND GEOLOGY
FAULT EVALUATION REPORT FER-244
SUPPLEMENT No. 1

SIMI-SANTA ROSA FAULT ZONE
Ventura County, California

by
Jerome A. Treiman
March 31, 1999

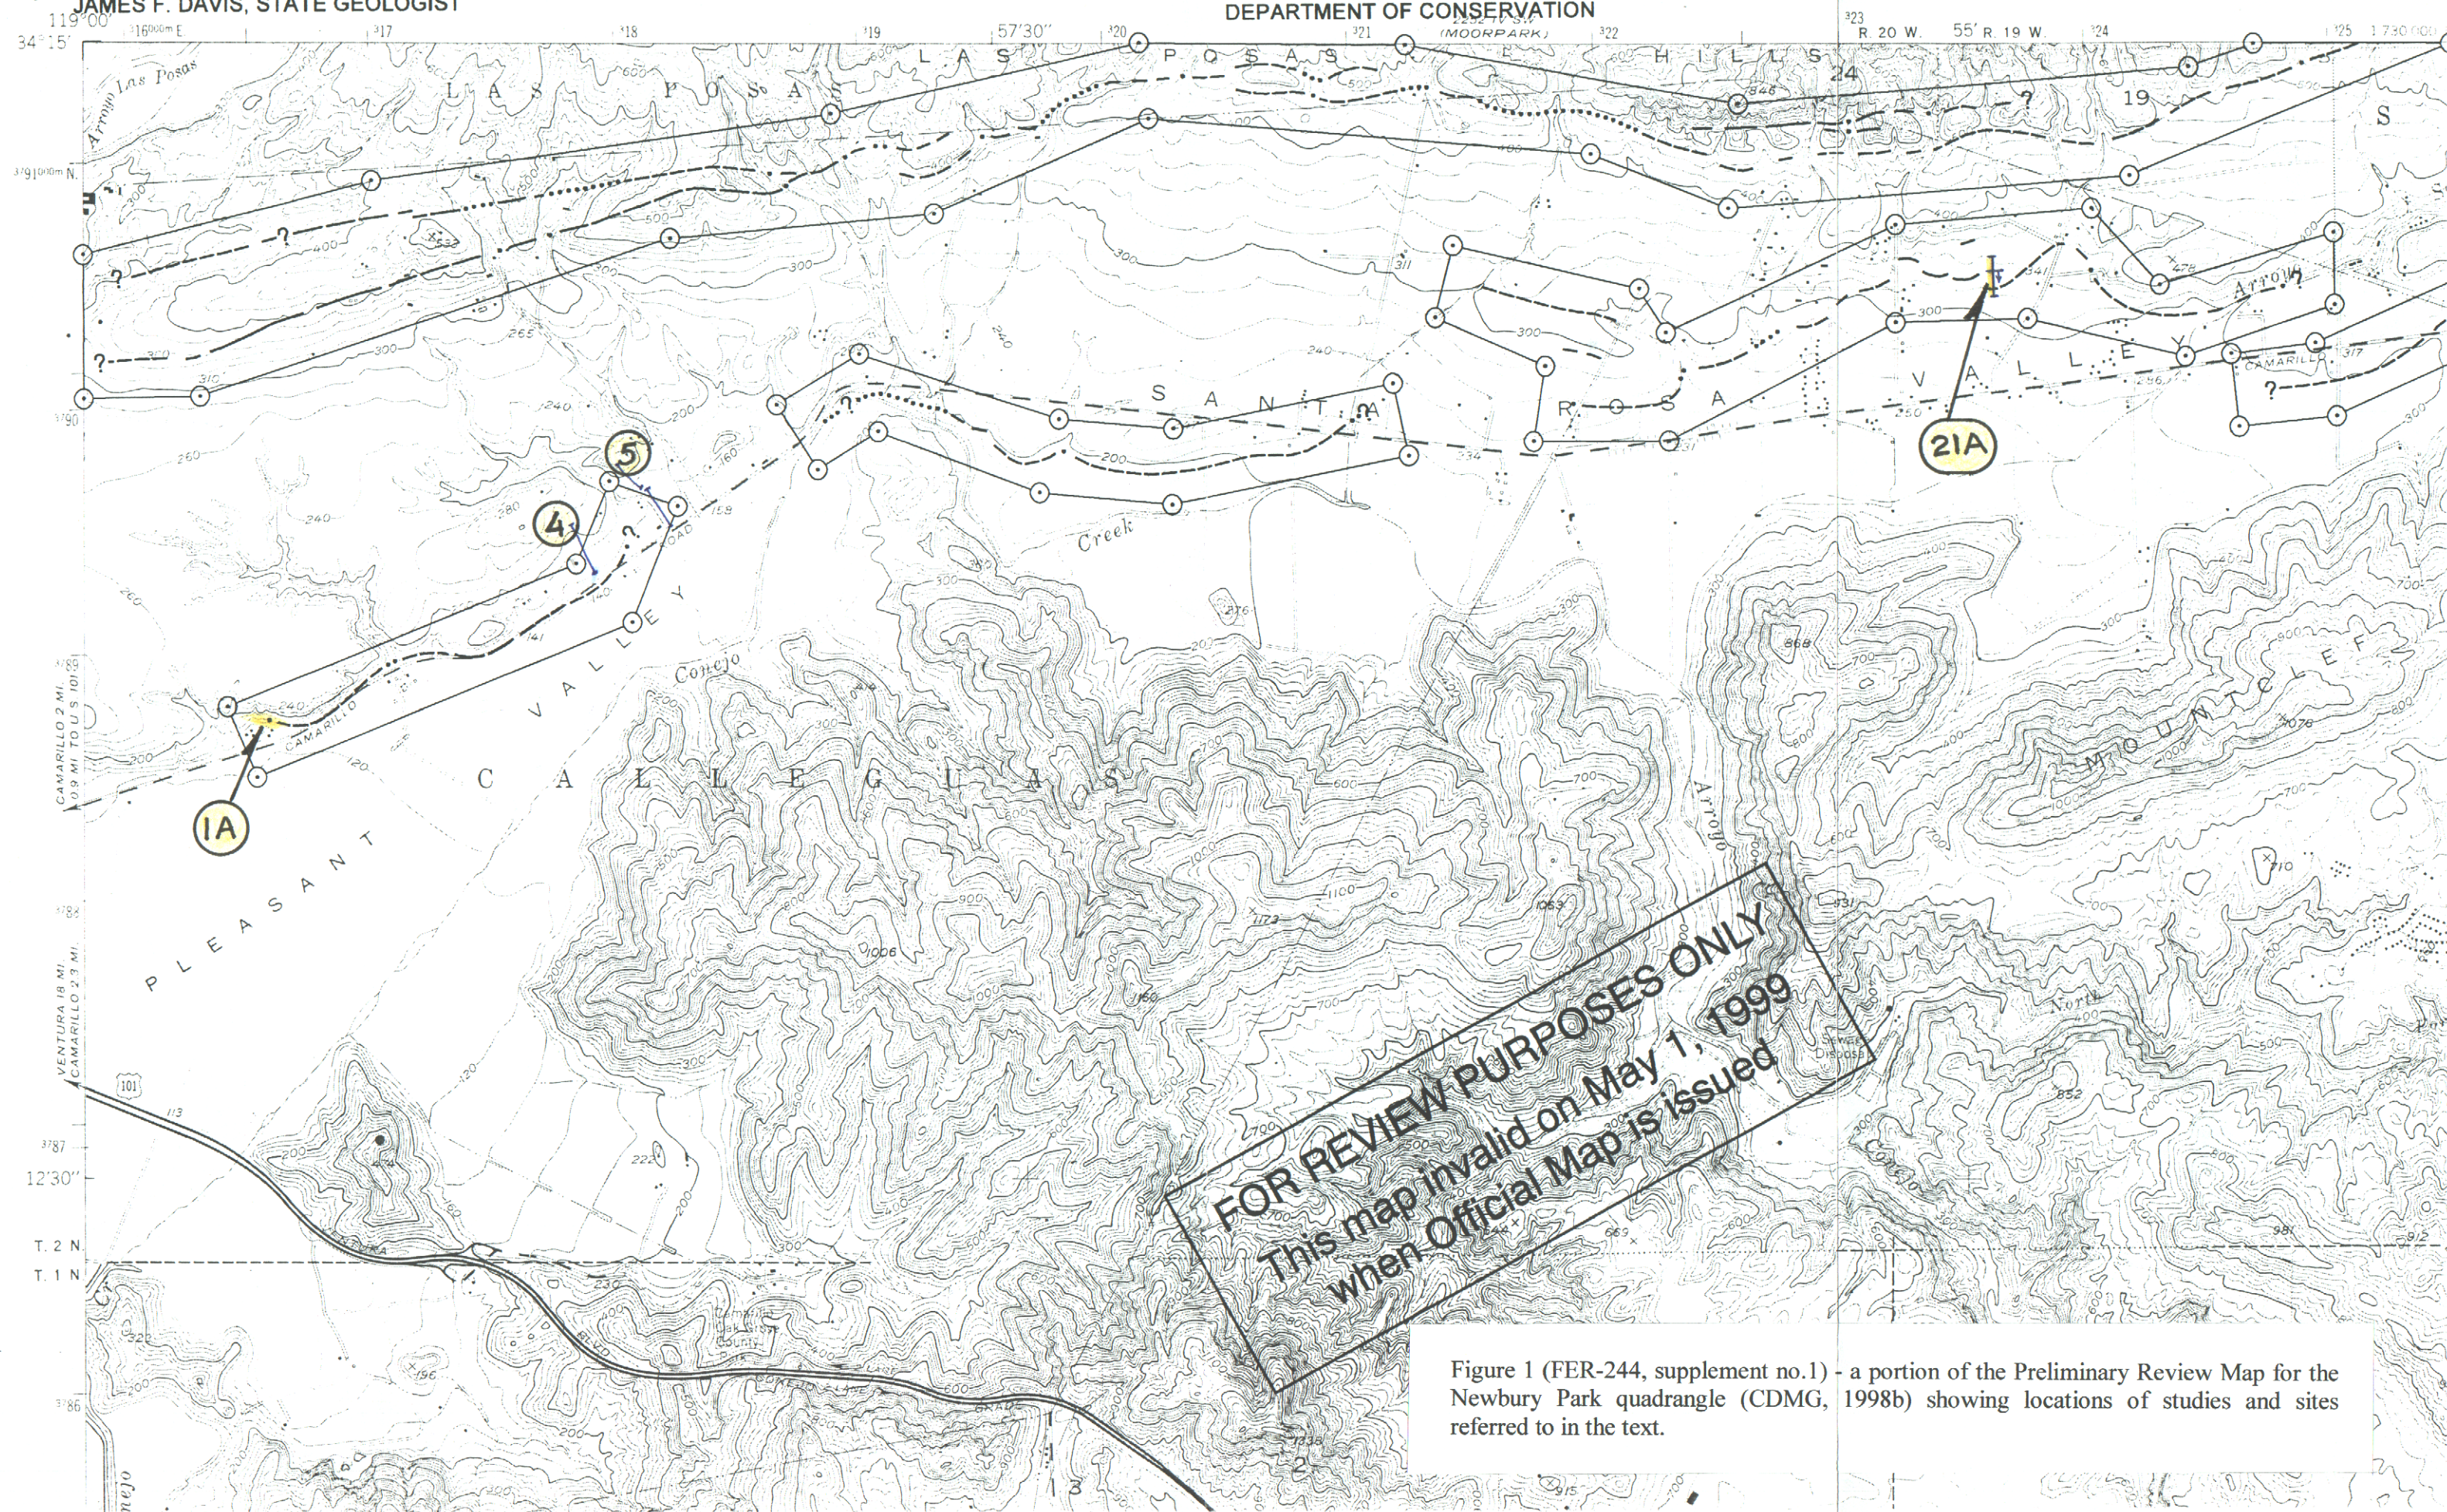
Figure 1 (FER-244, supplement no.1) - a portion of the Preliminary Review Map for the Newbury Park quadrangle (CDMG, 1998b) showing locations of studies and sites referred to in the text.

#1. Earth Systems Consultants (1999) submitted a request for reconsideration of the proposed zoning of the Santa Rosa Valley fault in the vicinity of localities 4 & 5 (Figure 1), asking that the EFZ (Newbury Park quadrangle – California Division of Mines and Geology, 1998b) be reduced in length so as to not impact the eastern parcels (vicinity of locality 5). They supported their request with the submittal of geotechnical studies for three adjacent projects, (Buena Engineers, 1988a; Earth Systems, 1997a & 1998a), including four reports not previously reviewed (Earth Systems, 1997c,d & 1998b,c).

No data was submitted that would affect the proposed zoning. The existing data, although showing lack of faulting in the young, upper alluvial materials within part of the proposed zone, did not demonstrate the absence of faulting at greater depths nor did the data refute the principal fault on which the zone is based.

#3) I was invited (in late December, 1998) to view trenching in progress at locality 1A (see Figure 1), being done by GeoSoils, Inc. Several trenches across the toe of an escarpment associated with the Santa Rosa Valley fault exposed moderate to high-angle reverse faults, including backthrusts. Adjacent beds of the Pleistocene Las Posas Formation were deformed severely and were overturned in some instances. Some of the faults appeared to displace colluvium or slope wash. Additional work in the alluvium south of the escarpment (utilizing CPT's) is reported to have located what may be the main buried thrust fault (Joe Cota, GeoSoils, personal communication, 1999).

#4) I was also invited (in November 1998) to observe a trench approximately 7km to the east, excavated by C.Y. Geotech, Inc. across a broad scarp or warp associated with the Santa Rosa Valley fault (locality 21A, Figure 1). Although this trench was only open a relatively short time and was incompletely cleaned at the time of my observation, a backthrust (dipping 43°S) was clearly exposed that offset and deformed late Quaternary alluvial deposits and may have affected soil thickness. The main thrust was not exposed, but Quaternary fan deposits were inclined 30°-40°S within the inferred upper plate. It is

possible that the main fault is blind at this locale and the observed fault was an intercalation backthrust.

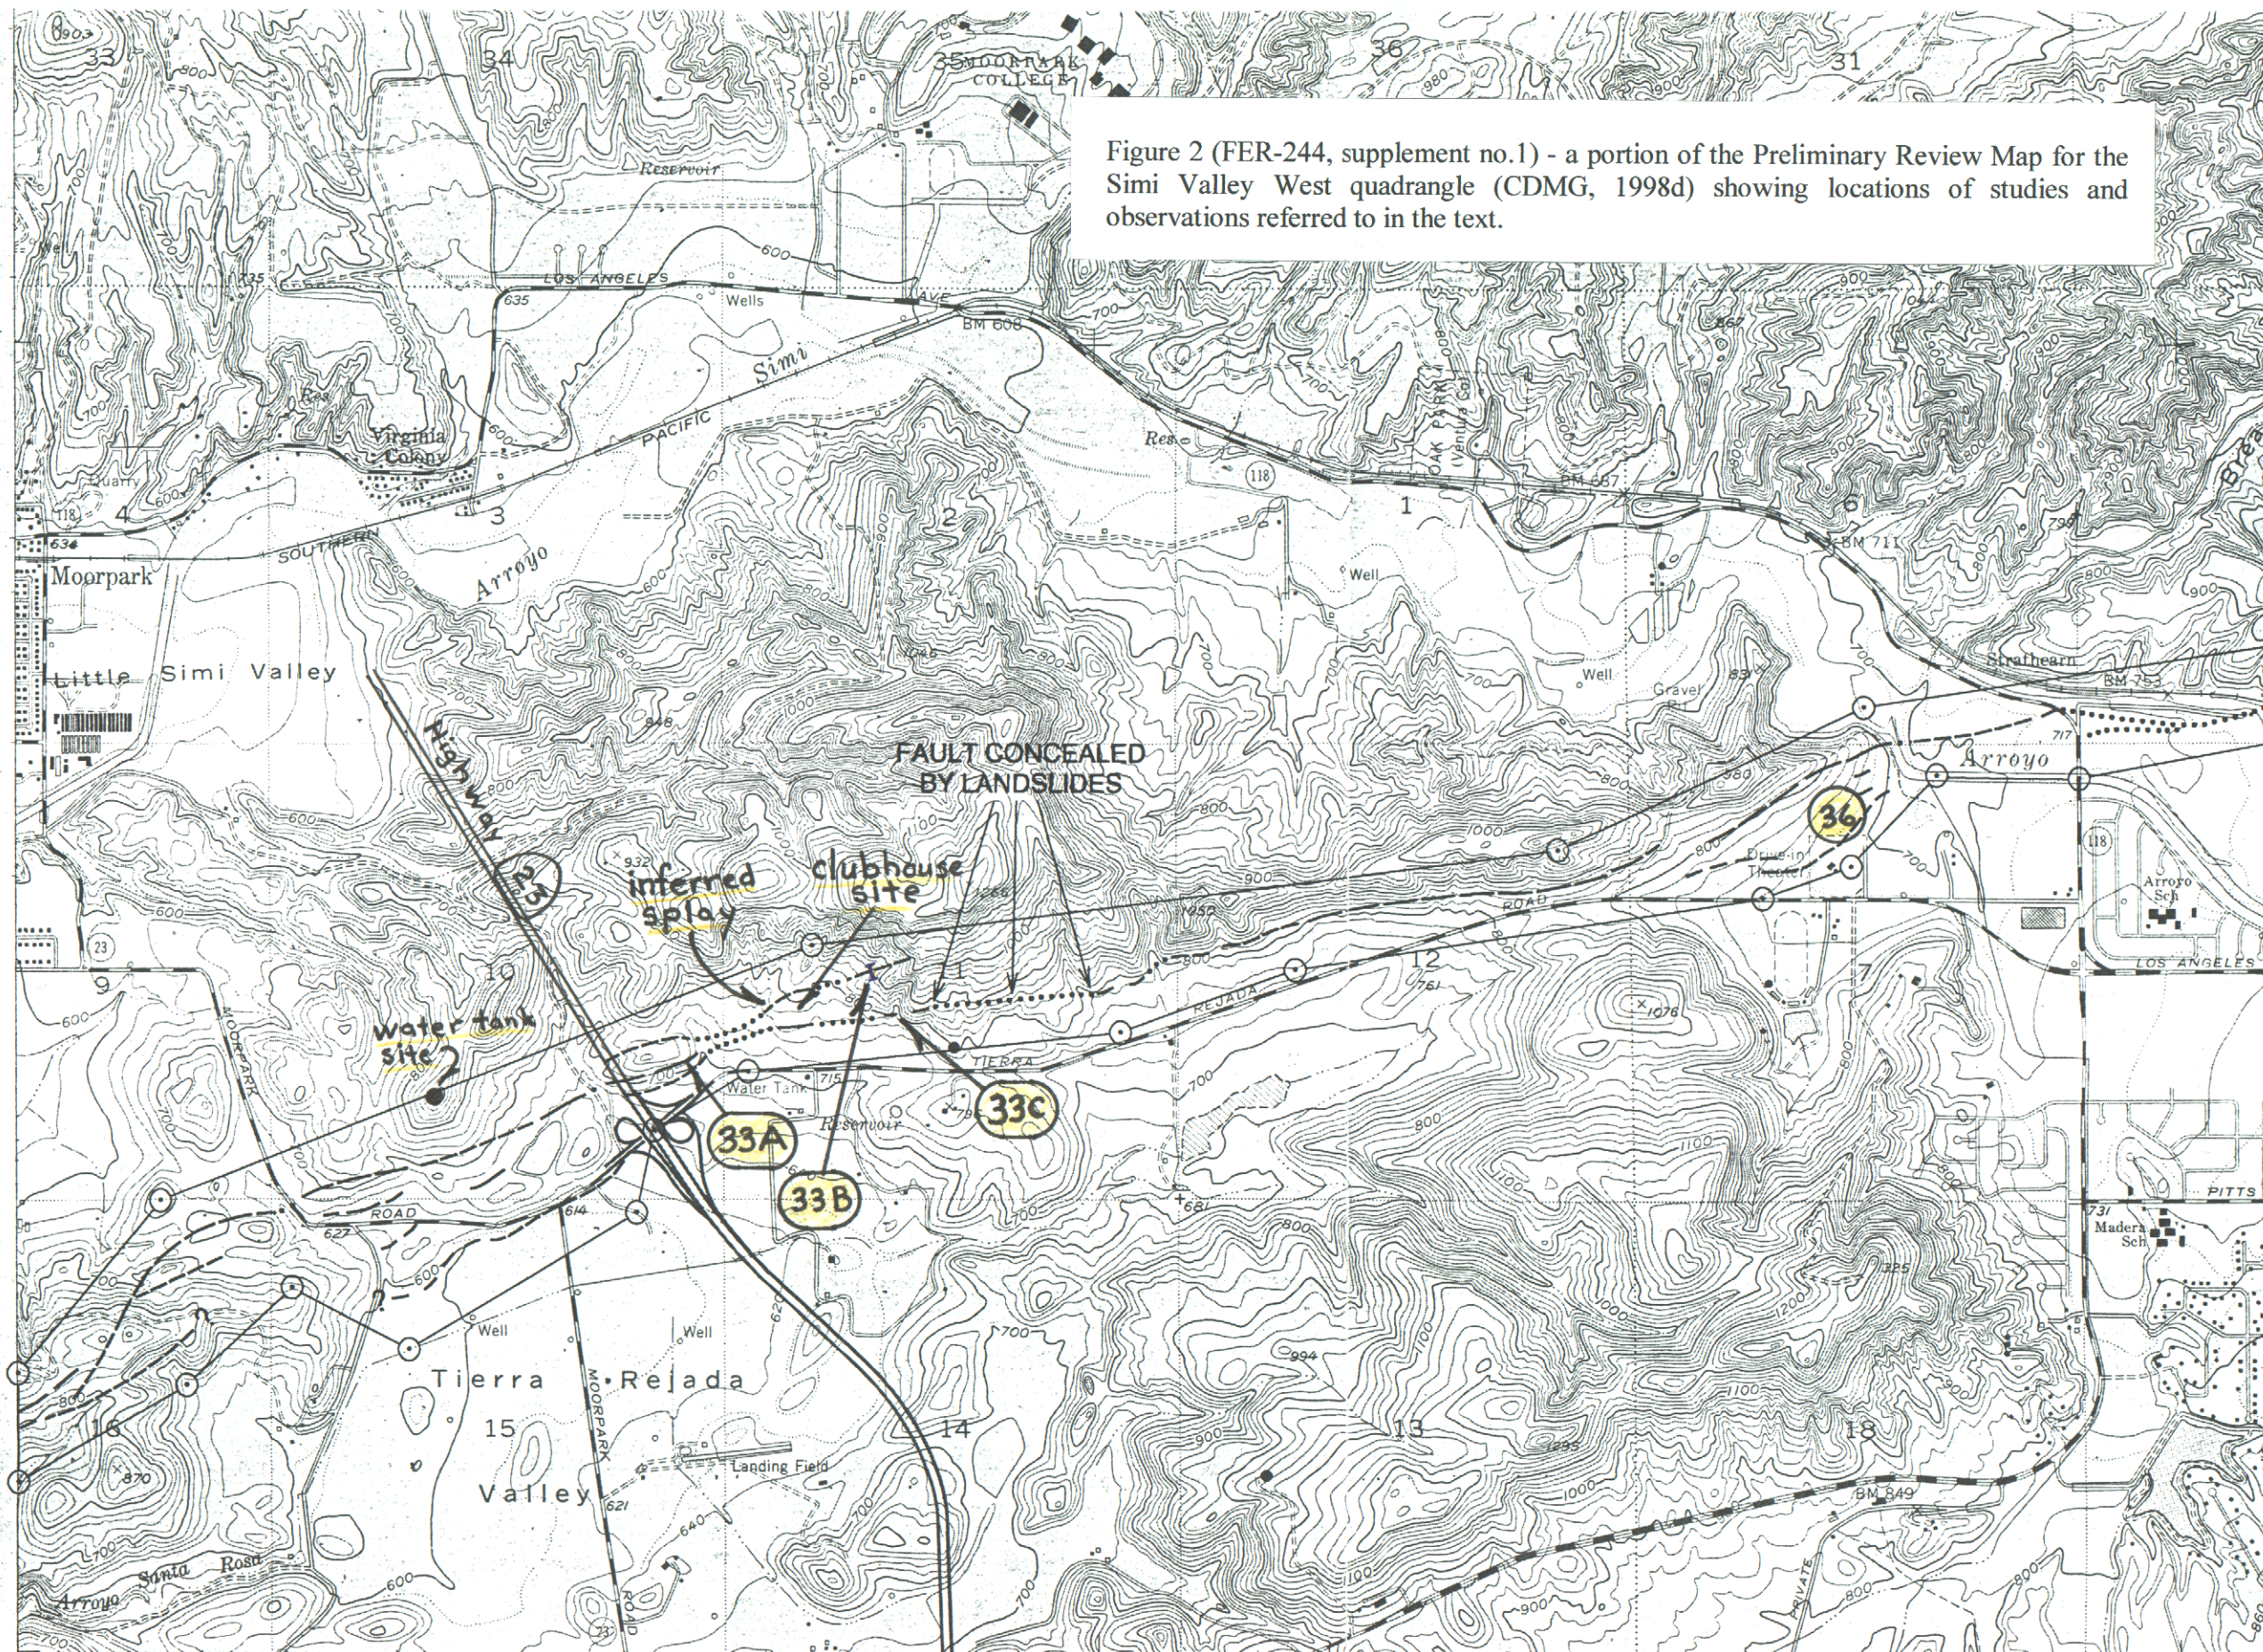
Figure 2 (FER-244, supplement no.1) - a portion of the Preliminary Review Map for the Simi Valley West quadrangle (CDMG, 1998d) showing locations of studies and observations referred to in the text.

I was invited to the golf course site to observe investigations in early December 1998. The main fault trace of the Simi fault was exposed in a cut-slope (locality 33A, Figure 2) and in a canyon clean-out to the east (locality 33C, Figure 2). A trench was excavated across one of the stronger topographic features that was originally taken as an indication of the inferred fault strand (locality 33B, Figure 2). I inspected the trench, along with Scott Simmons of Gorian and Associates, and although two bedrock shears were observed within the Oligocene Sespe Formation south of the topographic break, these shears did not correspond to the suspect topographic feature. The topographic irregularity may have been due to resistant bedding or increased erodeability of an inset Quaternary channel deposit. No evidence was observed to warrant retention of the eastern part of the inferred fault splay through and east of the clubhouse site.

A bedrock fault was observed in grading being done to the north of the main strand (north of locality 33A), at the western side of the project. The age of this latter fault was not determinable due to stripping of the younger soils, but its location and orientation warrant keeping the eastern portion of the splay fault within the EFZ.

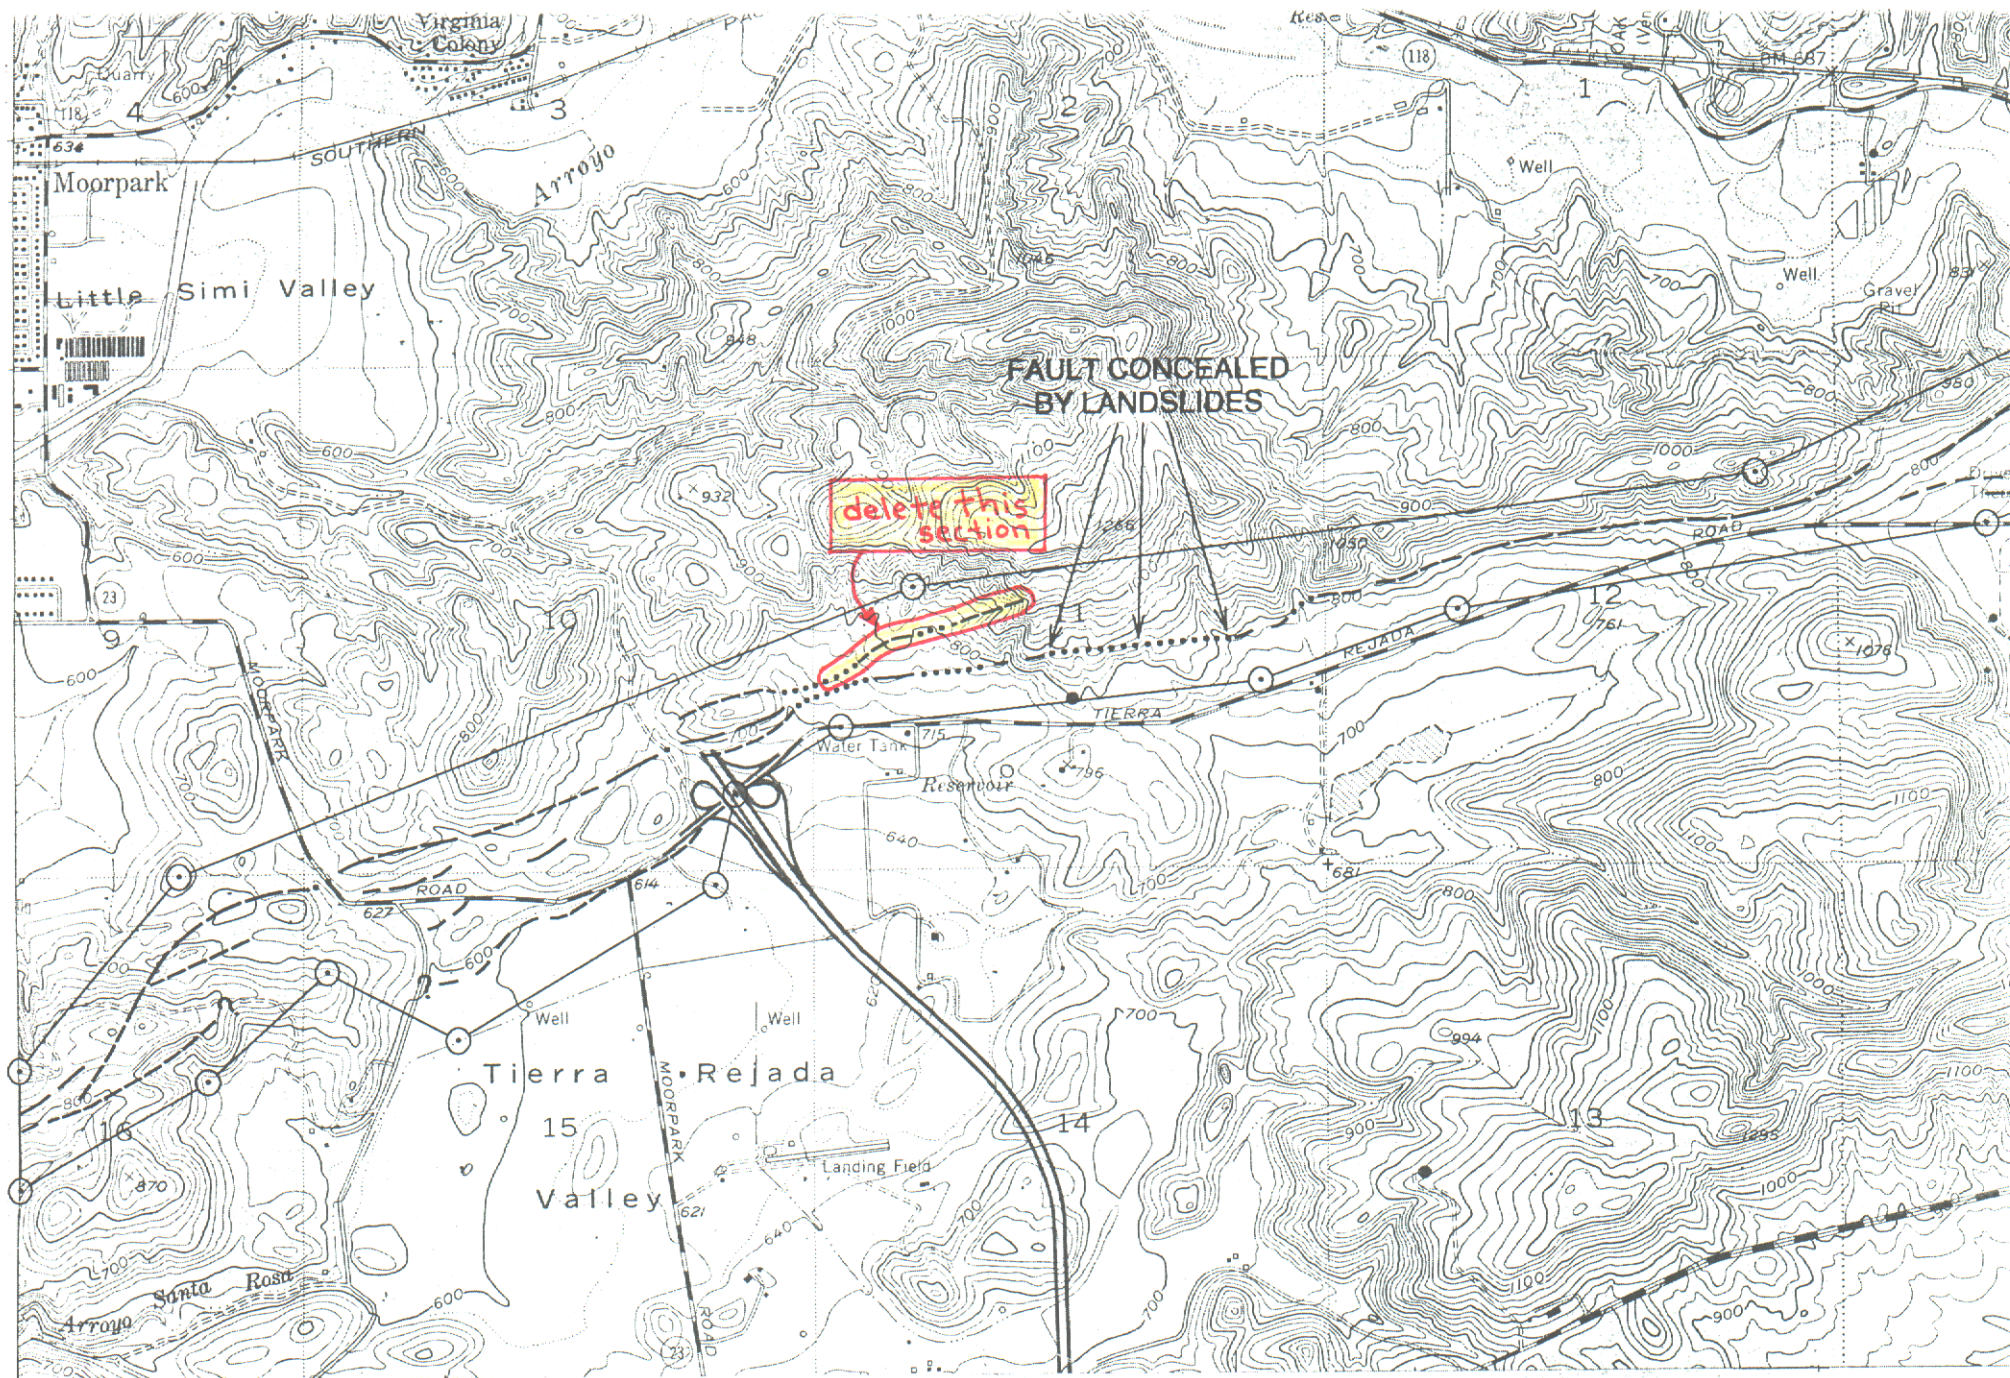
Figure 4 (FER-244, supplement no.1) - a portion of the Preliminary Review Map for the Simi Valley West quadrangle (CDMG, 1998d) showing the fault splay recommended for deletion.

#2. Gorian and Associates submitted a letter and map (Gorian, 1999) addressing the zoning of the Simi fault north of Tierra Rejada Valley on the Simi Valley West quadrangle (California Division of Mines and Geology, 1998d). Observations made by the consultant during extensive grading for a golf course, east of Highway 23, did not find any evidence for the eastern portion of an inferred fault splay, north of the main trace, as shown on Figure 2. They also noted that in various studies west of Highway 23, in particular a water tank site, they had observed no faulting north of the Simi fault as shown on the preliminary review map. Based on these observations they have requested that the northern fault trace be deleted and that the EFZ be narrowed on the north. A small fault observed during subsequent grading of the clubhouse site was closer to the

main trace (~240') than the mapped splay, but no evidence was seen of the northern trace (Scott Simmons, Gorian & Associates, personal communication, 1999).

The Earthquake Fault Zone for the Simi Valley West quadrangle (California Division of Mines and Geology, 1998d) should be modified as indicated on Figure 4. The EFZ's for Simi-Santa Rosa fault zone on the Newbury Park, Moorpark and Simi Valley East quadrangles (California Division of Mines and Geology, 1998a,b,c) should remain as proposed.
